European Geosciences Union General Assembly 2017, EGU  
Division Energy, Resources & Environment, ERE

## Effects of heat shocks on biofilm formation and the influence on corrosion and scaling in a geothermal plant in the North German Basin

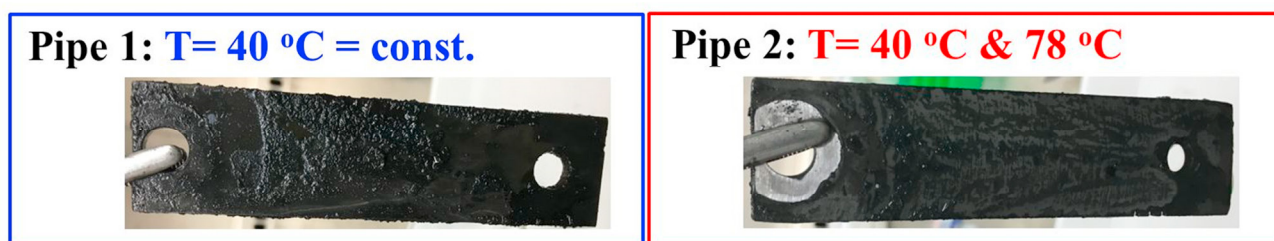
Fig. 1. The biofilm layer on the coupon treated with heat shocks (pipe 2) is much thinner than on the coupon with constant 40 °C (pipe 1).

In the geothermal plant in Neubrandenburg, damages on the submersible pump due to microbial influenced corrosion were observed. In order to develop measures against corrosion damages, the influence of short-term heat shocks on the biofilm formation was investigated. After the fluid exposure at a constant temperature in pipe 1 and with heat shocks in pipe 2, the biofilm layers differed strongly in their thickness. On the coupon exposed to heat shocks the biofilm layer was much thinner than the layer on the coupon with constant temperature (Fig. 1).

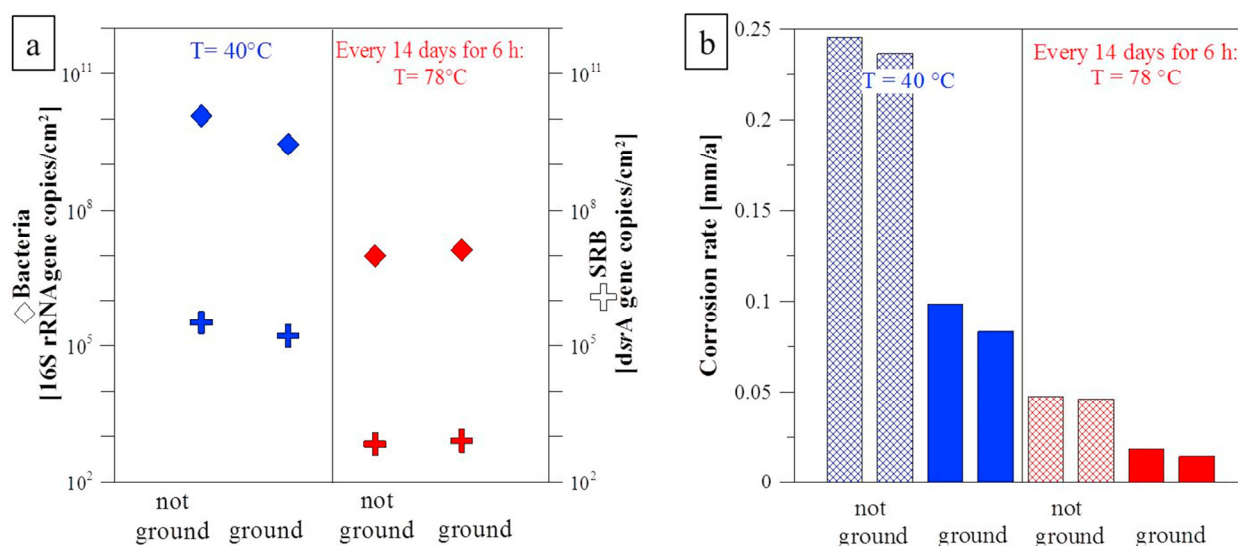
Fig. 2. (a) Lower abundance of Bacteria and SRB on the coupons with heat shocks, (b) lower corrosion rates of the coupons with heat shocks.

Corresponding to the lower thickness of the biofilm layer after heat shocks, the abundance of Bacteria as well as the abundance of the SRB were about 1000-fold lower and thus, strongly reduced (Fig. 2a). Correspondingly, the corrosion rates were fivefold lower (Fig. 2b). Furthermore, the corrosion rates also differed depending on the treatment of the coupon surface. The ground coupons were less influenced by corrosion than the unground coupons.

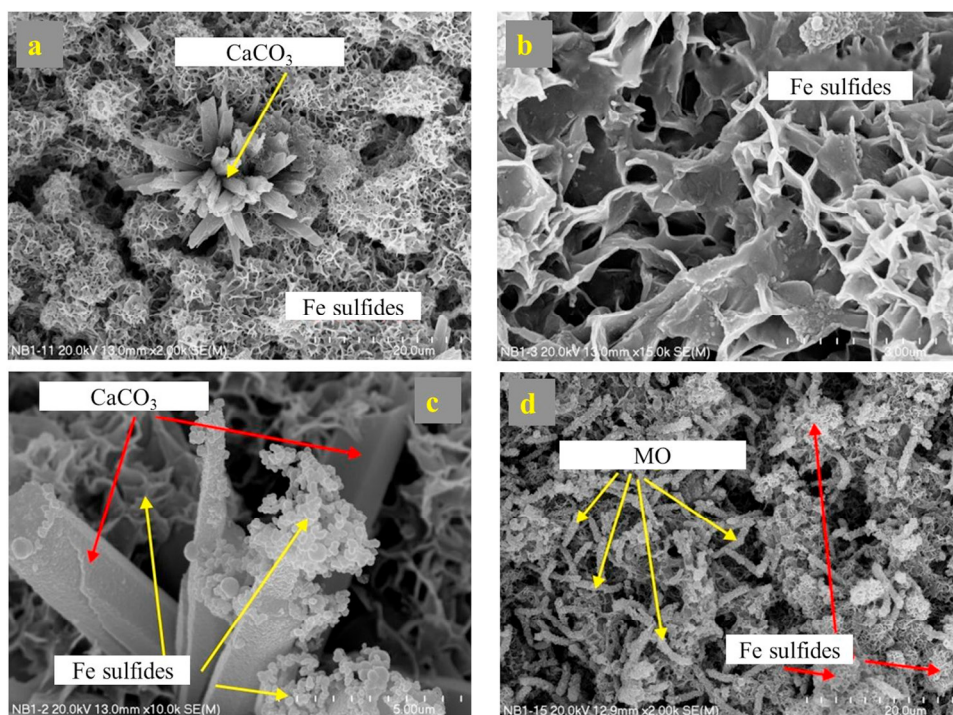
Fig. 3. (a-d) SEM pictures and EDS results of the biofilm with microorganisms (MO) covered with minerals on the coupons without heat shocks after the exposure to the fluid in the bypass system located at the geothermal store in Neubrandenburg.

SEM images combined with EDS analyses showed that the solid material phases on the coupon were dominated by iron sulfides and calcium carbonates (Fig. 3 a-d). Microorganisms in the form of elongated rods were frequently found in close relation to iron sulfides as shown in Fig. 3d. This suggests that those microorganisms might be SRB. According to Lerm et al. [5] and Westphal et al [12], SRB affiliated to *Desulfotomaculum*, *Desulfohalobium* and
